Inspection Report

Pre- Foundation Sample

PROPERTY INSPECTION REPORT

I. Structural Systems

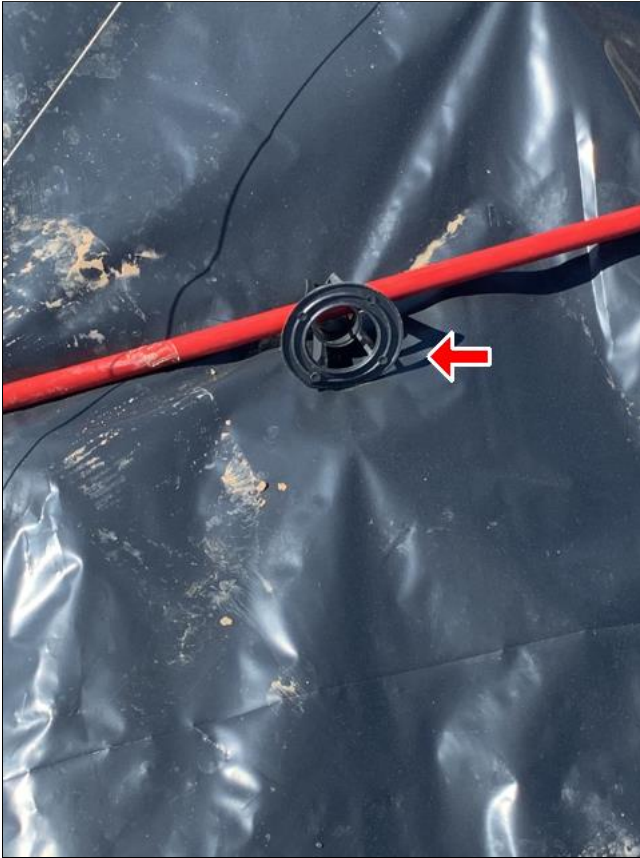
A. Item 1(Picture)

- (1) Foundation elevation readings vary approximately 0.7" from high to low measurements.
- (2) Install all post tension cables vertically on chairs. Many of the chairs throughout the form are not upright

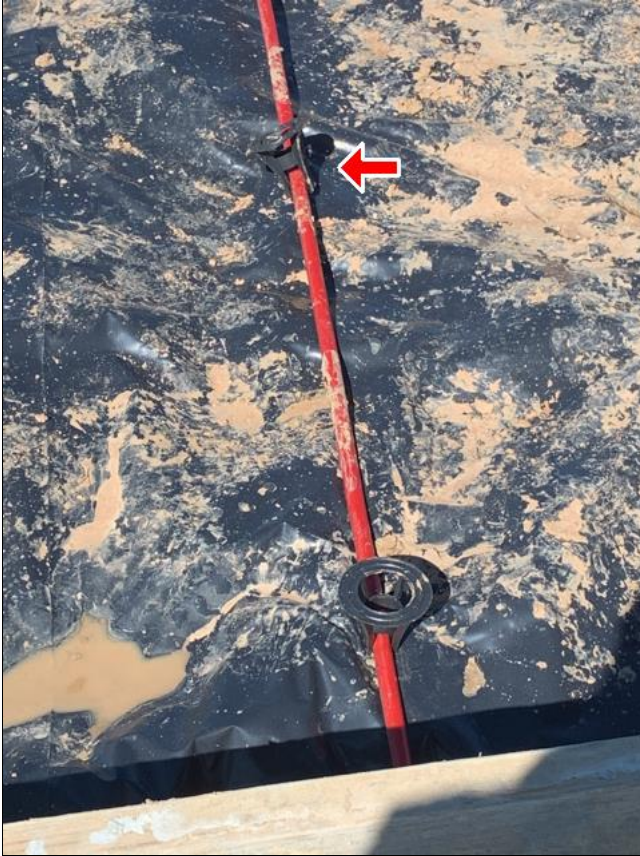
A. Item 3(Picture)

(3) Remove all unused debris from the form prior to pouring concrete. This includes unused rebar, unused nails, unused chairs, and wood debris
